GARVER ARTS INCUBATOR
 COMMON WEALTH DEVELOPMENT, INC.
 HPZS - ARCHITECTS / ENGINEERS
 06/01/10
 SHEET 8

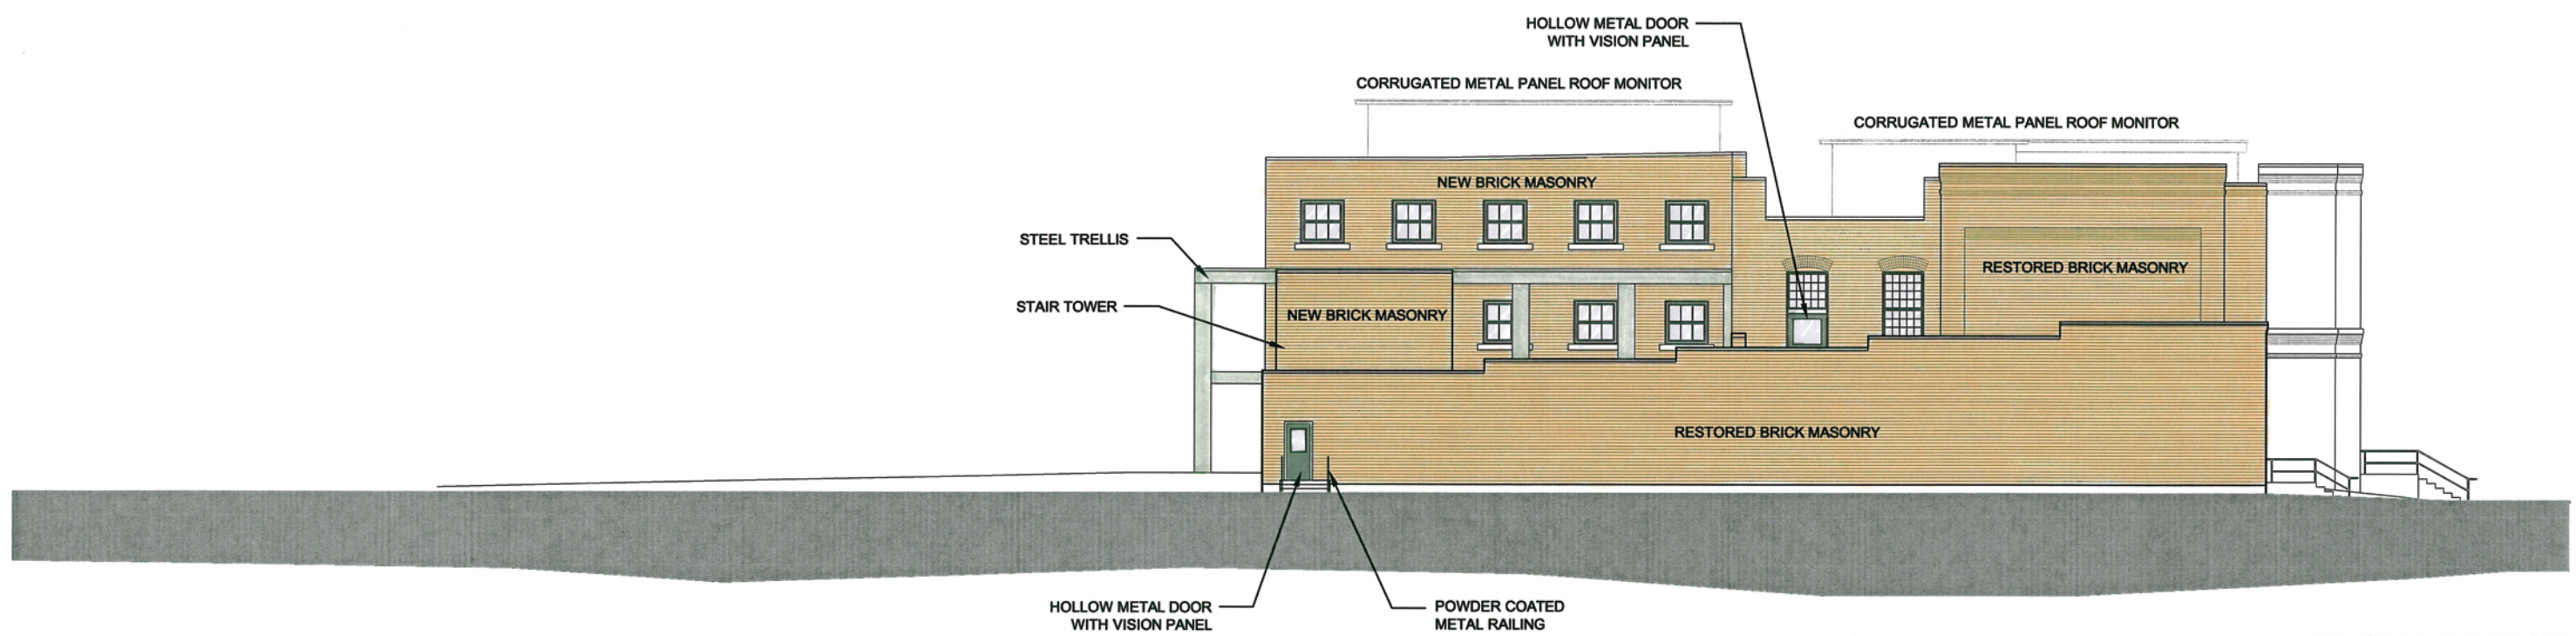
WEST ELEVATION

- TYPICAL WINDOW:**
- PRE-FINISHED ALUMINUM, DARK GREEN OR DARK BROWN COLOR
 - THERMALLY BROKEN SASH AND FRAME ASSEMBLY
 - INSULATED GLAZING
 - DIVIDED LITES REPLICATING ORIGINAL MUNTIN PATTERN AS CLOSELY AS POSSIBLE BASED ON HISTORIC PHOTOS
 - MUNTIN AND BRICK MOLDING PROFILES TO BE HISTORICALLY CONSISTENT WITH PUTTIED GLAZING BEAD AND WITH INDUSTRIAL CHARACTERISTICS OF BUILDING'S ORIGINAL USE (SEE ATTACHED EXAMPLES FOR GENERAL REPRESENTATION)
- TYPICAL MASONRY RESTORATION:**
- TUCKPOINT 100%
 - DISMANTLE AND REBUILD DETERIORATED PARAPETS TO EXTANT ORIGINAL CONFIGURATION AND PROFILE
 - REMOVE NON-HISTORIC INFILL MATERIALS TO RESTORE ORIGINAL WINDOW MASONRY OPENINGS
 - REPAIR AREAS OF DETERIORATED BRICK MASONRY WITH SALVAGED AND/OR MATCHING BRICK MASONRY
